**BRAZILIAN MARITIME AUTHORITY
DIRECTORATE OF PORTS AND COASTS**

**CASUALTY OF M/T "BAHAMAS" AT RIO GRANDE
- 30 AUGUST 1998 -**

INVESTIGATION REPORT

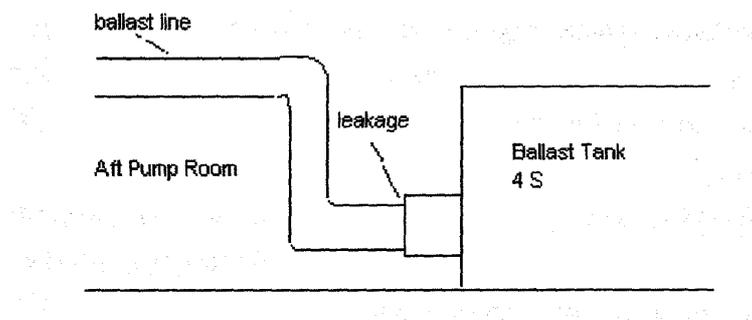
The ship continued to discharge and, at the end of this operation, began to receive ballast water in Ballast Tanks 4S and 4P, in order to trim the vessel. After some minutes, the Pumpman went down to the Pump Room and noticed a leakage through the sleeve of the ballast line of Ballast Tank 4S, as can be seen on the sketch below.

After seeing this leakage, the Pumpman informed the Chief Officer, who ordered to stop the Ballast Pump. The crew tried to stop the leakage by means of a clamp, but had no success. At this moment, the solution of acid and water had already gone to the Cargo Tunnel. The arrangement assembled on Cargo Pump 12S was used to pump the liquid to Cargo Tank 9S, which was empty at that time.

After noticing that the water leaking through Cargo Tank 4S ballast line was reacting with the acid left in the bottom of the aft pump room, thus generating a highly corrosive substance, the crew only tried to drain that liquid to a Cargo Tank and was not able to evaluate the risks this situation could pose to the ship.

The remaining liquid inside the Pump Room corroded the Ballast Lines located in the bottom of that compartment and, subsequently, the Cargo Lines, allowing a communication

between the Ballast Tanks and the Cargo Tanks through the aft Pump Room, originating a violent chemical reaction inside the ship.

I - Ballast pumps and ballast Unes should be located in order to avoid contact with any possible leakage of cargo lines and cargo pumps.
