**SUB-COMMITTEE ON
IMPLEMENTATION OF IMO
INSTRUMENTS
5th session
Agenda item 4**

**III 5/4
19 June 2018
Original: ENGLISH**

LESSONS LEARNED AND SAFETY ISSUES IDENTIFIED FROM THE ANALYSIS OF MARINE SAFETY INVESTIGATION REPORTS

**Report of the Correspondence Group on Analysis of Marine Safety
Investigation Reports**

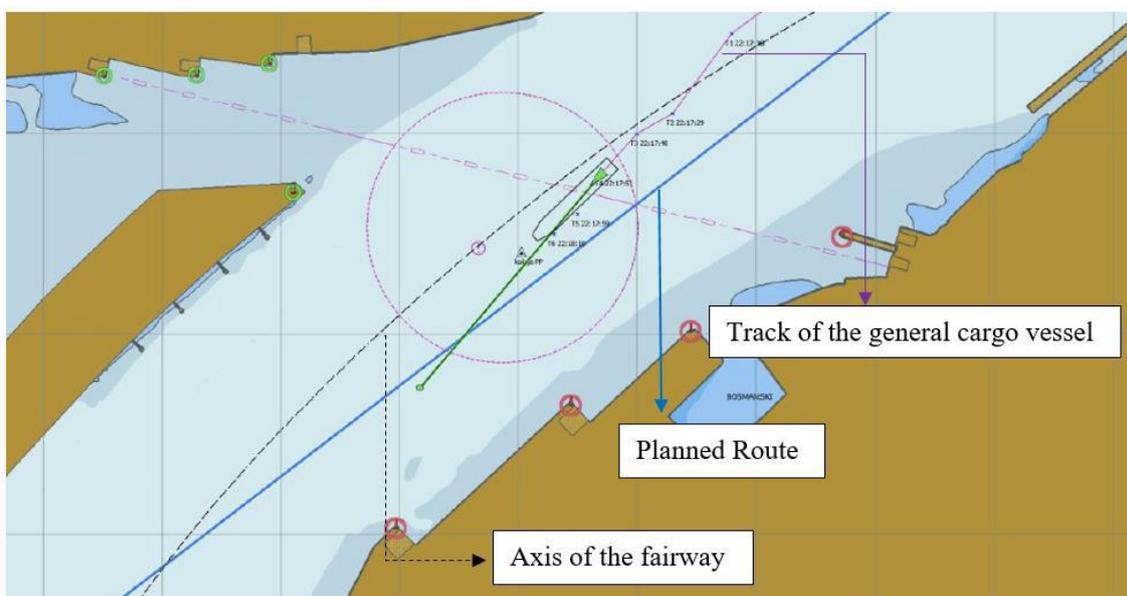
The general cargo vessel was manned only by the master who had not arranged for a proper lookout. Her radar had detected the echo of the tug boat on the starboard side at a distance of about 8 cables, but no action had been taken to determine the passing manoeuvres or to move to starboard to the outer limit of the fairway.

The master had altered his vessel's course following the planned course as laid in his electronic chart, unknowingly positioning his vessel at the wrong side of the fairway.

Photo 1 – The vessel's track (magenta line), the planned route (blue line), axis of the fairway (dashed black line) in the vicinity of the place of collision

The pilot, during the transit in the fairway, also did not intervene when the general cargo vessel's course was altered to port so as to navigate the vessel on the wrong side of the fairway.
