**BRAZILIAN NAVY
DIRECTORATE OF PORTS AND COASTS**

**CASUALTY OF PLATFORM “P-36”
- 20 MARCH 2001 -**

INVESTIGATION REPORT

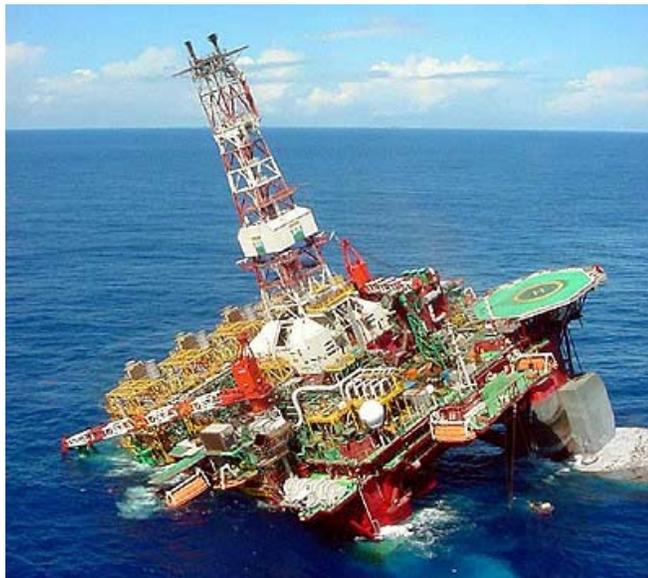
The platform continued to list as a result of the slow and progressive flooding, reaching 21 degrees around 3:00 p.m. on the same day.

P-36 listing

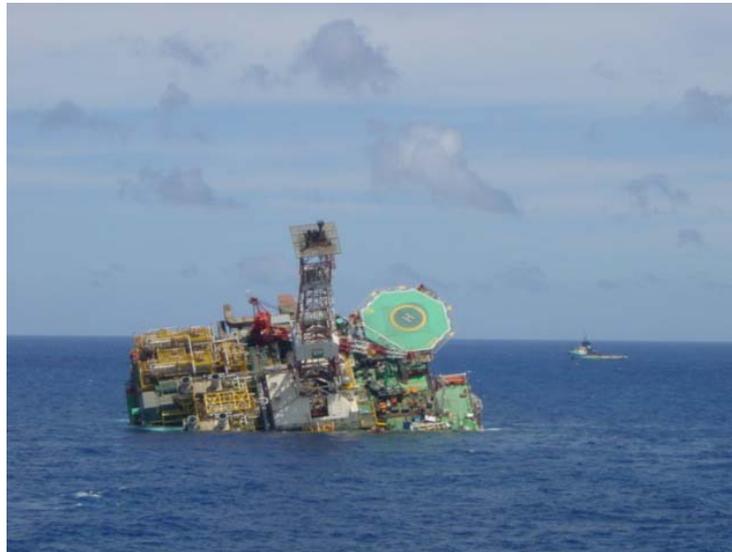
After midnight on March 20, the support vessel staff reported that the situation was worsening, when the platform reached a list of 30 degrees at 2:45 a.m.

P-36 in the morning of 20 March

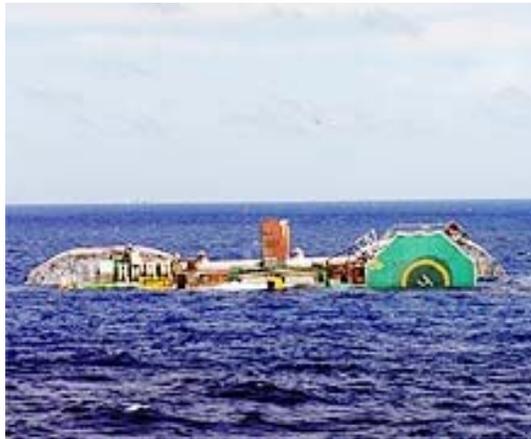
During the morning of March 20, the platform continued sinking and totally submerged around 11:40 a.m.

Platform continued sinking

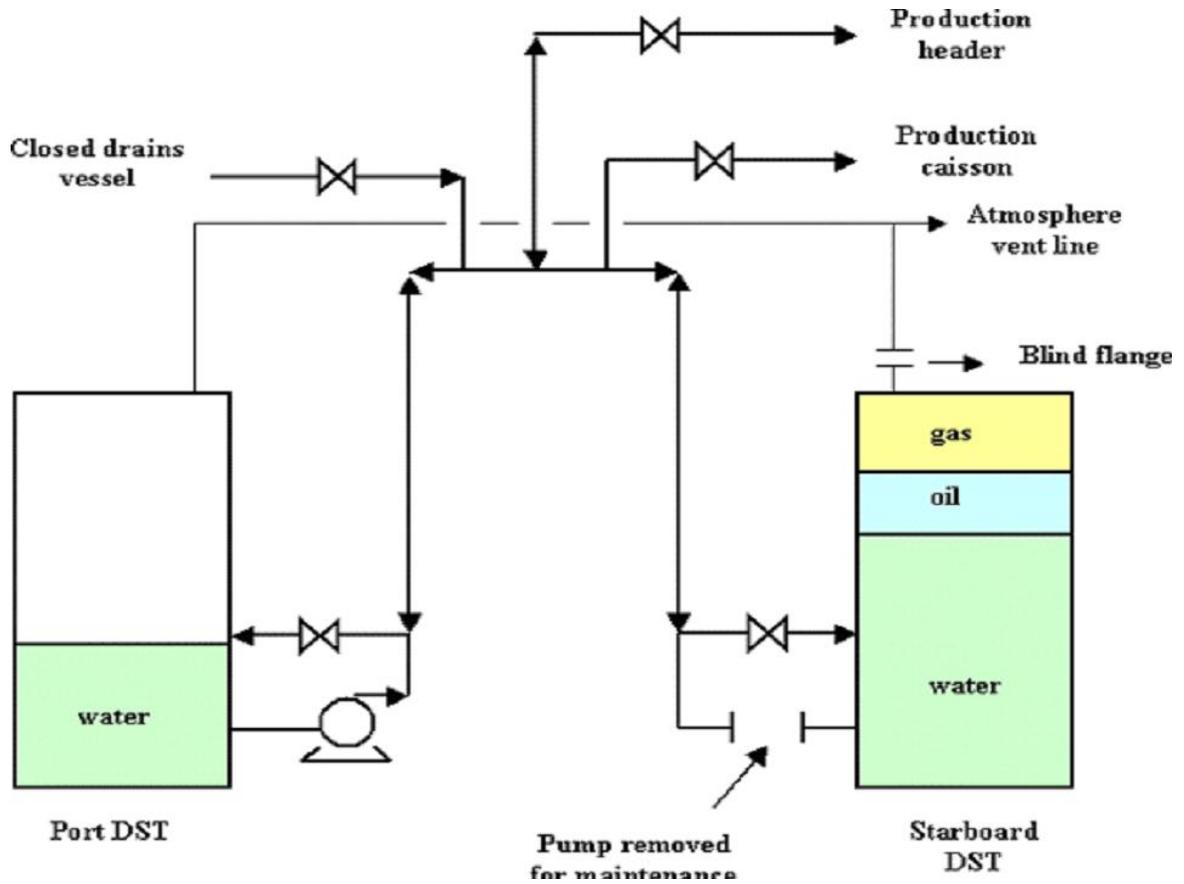
Annex 4.b
Process Flow Diagram of the Drains storage tanks
at the Time of the First Explosion

The drainage pump of the aft starboard drains storage tank was removed for repairs on February 10, when a considerable part of the tank's capacity was occupied by contaminated water, and it was not put back into operation. Subsequently the vent line of this tank was sealed with a blind flange to avoid water entering the tank from the open drain vessel due to the blockage of its draining, as can be seen in [Annex 4b](#) and [Annex 9](#).

The intake valve of the starboard tank allowed the passage of fluids into the tank, presumably because it was partially open or damaged. Consequently, since the tank vent line was blocked, as described above, continuous pressurization occurred in the tank as a result of incoming oil and gas from the production header.

An illustration of this scenario can be observed in [Annex 4.b](#).

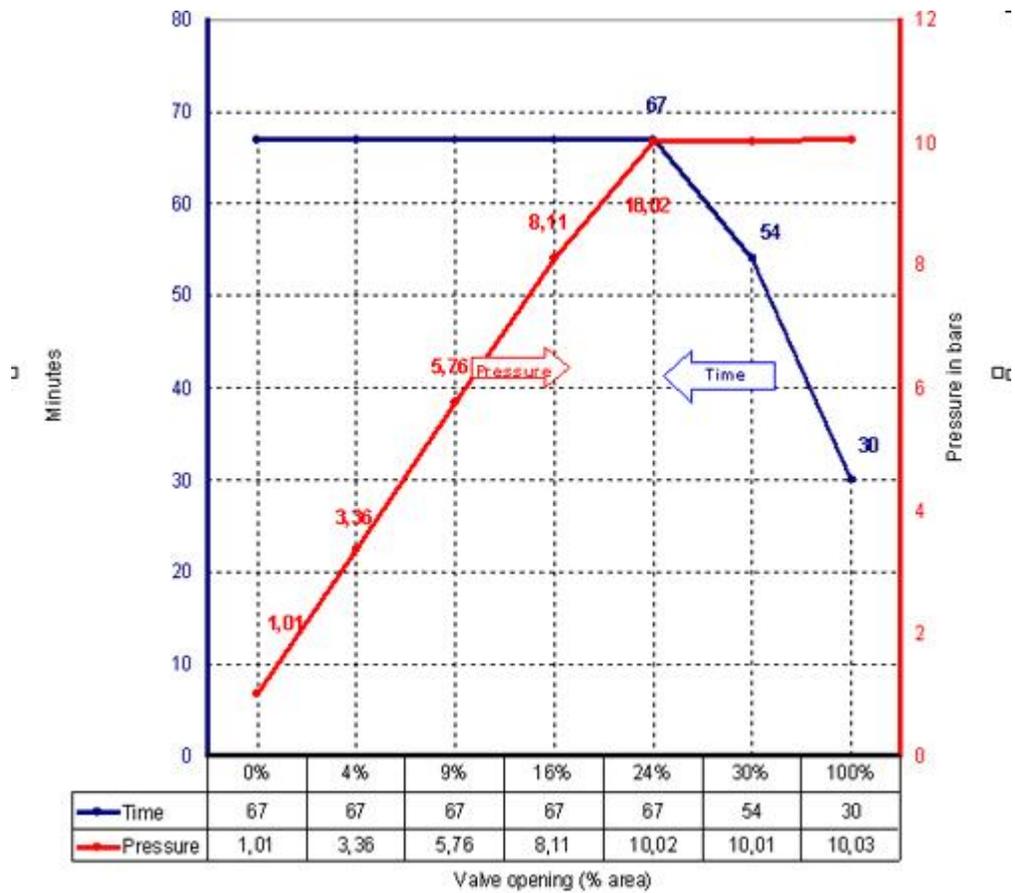
Annex 5

The aft starboard drains storage tank was pressurized during 121 minutes until it reached a pressure of around 10 bar, receiving approximately 13 cubic meters of oil, 1460 cubic meters of gas and 64 cubic meters of water, expressed at basic pressure and temperature conditions. These results were obtained from a mathematical simulation performed by ANP, considering an opening of the intake valve of 24% of its area to allow the tank to reach the above-mentioned pressure in 67 minutes after start-up of the port tank drainage pump, as can be seen in [Annex 5](#).

At 12:22 a.m. on March 15, upon reaching a pressure of around 10 bar, described by the Petrobras technical team as the failure pressure, the tank ruptured, releasing water, oil and gas to the inside of the column. The increase of the internal volume of the tank as a result of mechanical strain before failure was not taken into account.

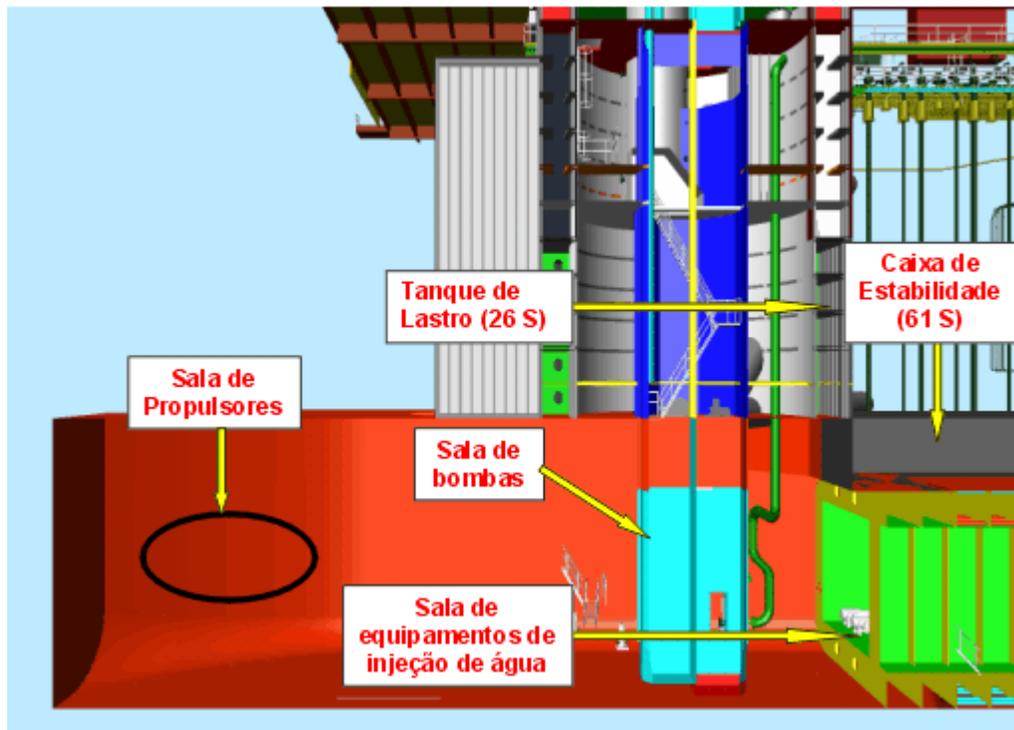
**Annex 8
Column and part of the Aft Starboard Pontoon**

On the day prior to the accident, the man holes that provide access to the ballast tank on the aft starboard column and the stability box located above the pontoon close to this column, had been opened to inspection of repairs of cracks found in this compartment. This inspection was programmed to take place on the following day.

- * failure in the functioning of the dampers of the column ventilation system, as a result of defects in their electro-hydraulic actuators;
- * man holes to the aft starboard ballast tank and the adjacent stability box left open during more time than necessary to perform the inspection and repair, altering the behavior of the platform considered in the intact and damaged status stability studies, contrary to the procedures stated in the Operation Manual - Item Hull and Structure - Water tightness;

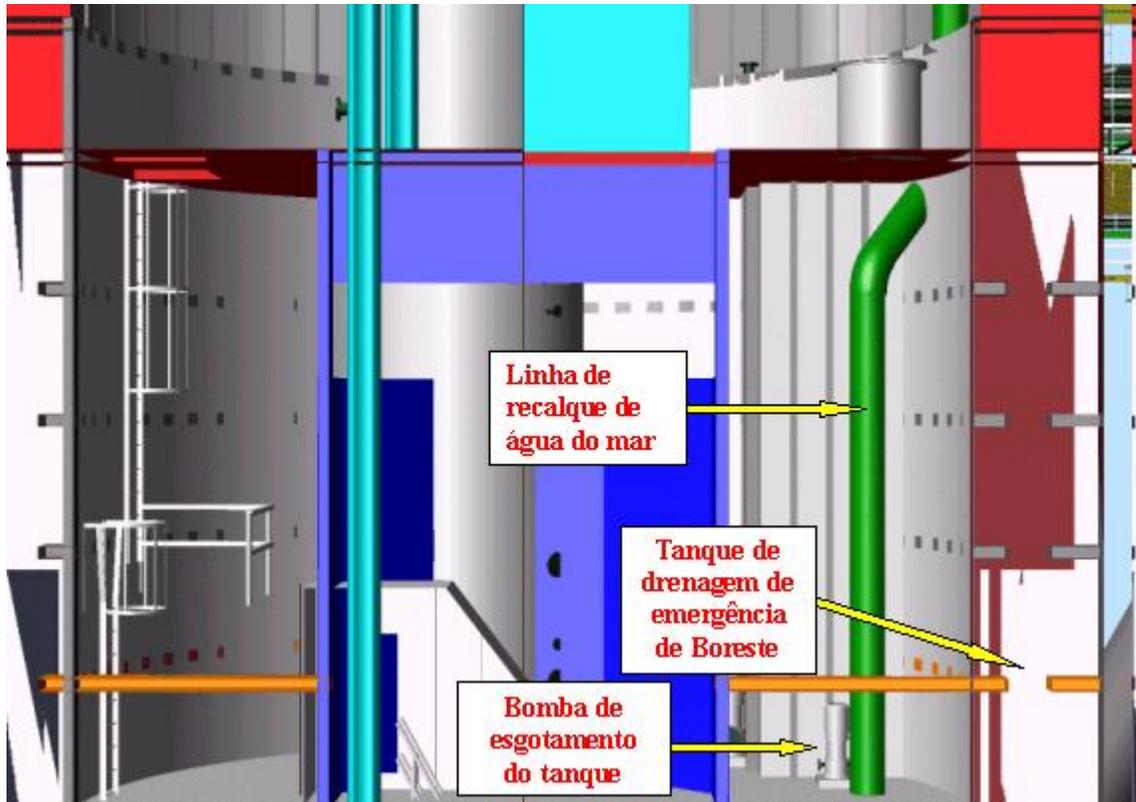
CASUALTY OF PLATFORM “P-36”
- 20 MARCH 2001 –
INVESTIGATION REPORT
Annex 9
Fourth level of the Aft Starboard Column

The collapse of the tank structure caused the transfer of the fluids inside it to the fourth level compartment, in addition to the rupture of the 18-inch saltwater pipe passing alongside it, beginning the flooding of the column. As a result the main fire ring line was depressurized, leading to the automatic shutdown of the process plant. The tank vent lines located below the third level of the column also ruptured.

The mechanical failure of the aft starboard drains storage tank, followed by the rupture of a section of the salt water pressurized line passing close to the tank at the fourth level, led to the flooding of the column. The determining cause of this incident was the following:

- * water and oil from the collapsed tank invaded the fourth level compartment;
- * the salt water pumps located aft starboard and forward starboard, activated automatically by the depressurization of the main fire ring line, continually increased the flooding through the fractured pipe; and
- * all the remaining water from the seawater system and the main fire ring line flowed by gravity to the fourth level compartment.
