**BRAZILIAN NAVY  
DIRECTORATE OF PORTS AND COASTS**

**INVESTIGATION REPORT OF THE CAPSIZING  
OF THE CONVOY “NORSUL 12 AND NORSUL VITÓRIA”**

**SÃO FRANCISCO DO SUL - SANTA CATARINA**

**- JANUARY 30, 2008 -**

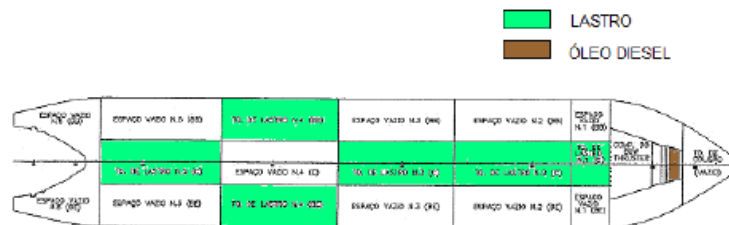
Lastro = Ballast  
 Óleo Diesel = Diesel Oil

Below is a sketch with the arrangement of ballast and diesel oil, it is observed that the major part of the ballast is placed on the Centre Line of the barge and only the ballast tanks No.4, which serve the anti-heeling systems are placed at the sides.

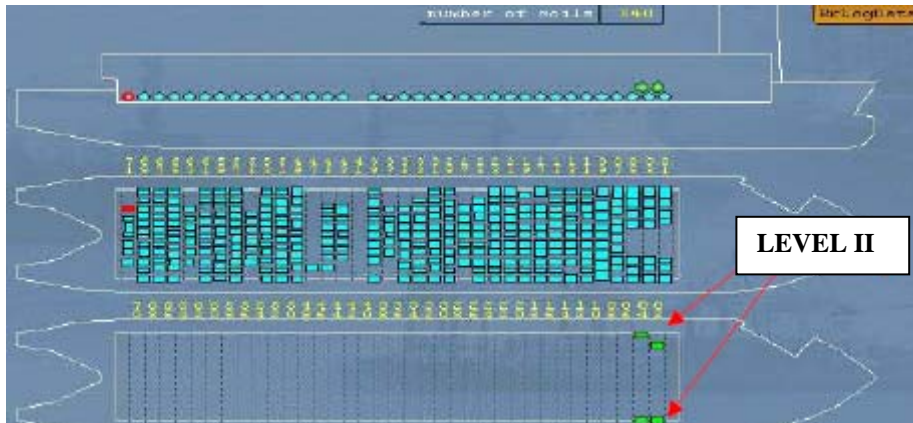
## **DISPOSITION OF THE COILS**

It should also be registered that, even though that in the document “Leaflet of Trim and Stability”, no. 1D10-110, issued by PROJEMAR S.A. it is informed by this company in item 4 NOTES ABOUT THE LOADING, that “coils destined for road transport, with a maximum of 13 t can be transported in two layers”, furthermore the conditions of loading in 11 TYPICAL CONDITIONS OF LOADING do not contemplate coils with weight above 13 t on Level II, the barge “NORSUL12” carried 04 coils with unitary weight higher than 13t on Level II, as presented below:

It was also observed that there existed various row with vacant spaces between the coils and as presented in the document “Leaflet of Trim and Stability”, no. 1D10-110, that not one of the loading conditions presented there allows the existence of empty spaces between coils stowed in no.1 Level.

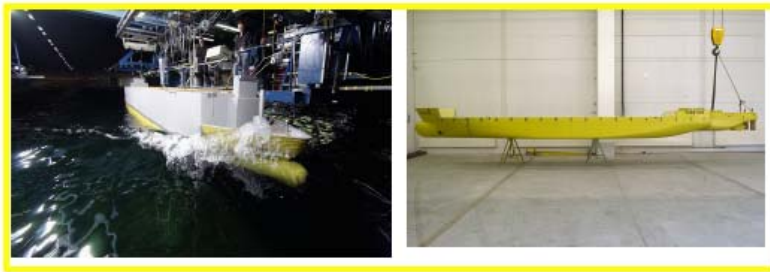
### **MODEL/TEST IN “MARIN”**

Despite the test with reduced models having indicated a pronounced heeling of the convoy, when carrying out zigzag manoeuvres, no technical document given to the owner emphasized this type of behaviour of the vessels.

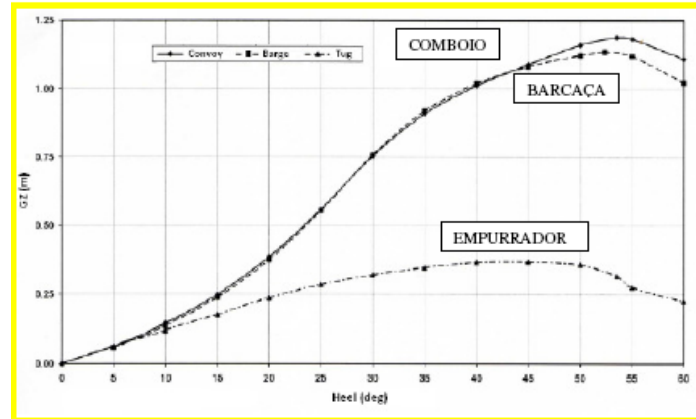
The Curve of Static Stability of the convoy, composed of curves of the pusher tug and the barge are found below. It is observed that the determinant in the stability of the convoy is the barge.

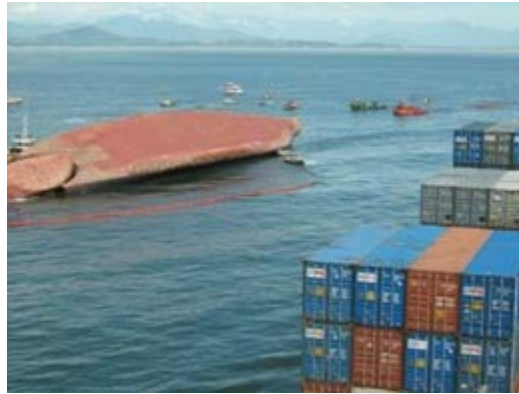
Only part of the sides and of the bottoms of the vessels were immersed, with a heeling of approximately 20°, as may be observed in the photos taken on the occasion. The upper part to port of the barge was touching the bed of the banks of the channel and starboard was approximately 3.0 metres from the bottom.

Excepting the dents in the bows of this tug, no damage to its quick works or to the side was observed. The after end was submersed and could not be observed during this survey. The barge “NORSUL 12” also did not present damages on its bottom and on the part of the side which was visible, however a strip located on the bottom, close to the port bilge keel indicated that this vessel had touched the bottom of the bay. The operation for discharging the oil onboard after the accident, was carried out by the Dutch company Smit Salvage BV. The company contracted to carry out the task of righting the convoy was the Dutch company Svitzer Wijsmuller.
