**BRAZILIAN NAVY
DIRECTORATE OF PORTS AND COASTS**

**CASUALTY OF PLATFORM “P-36”
- 20 MARCH 2001 -**

INVESTIGATION REPORT

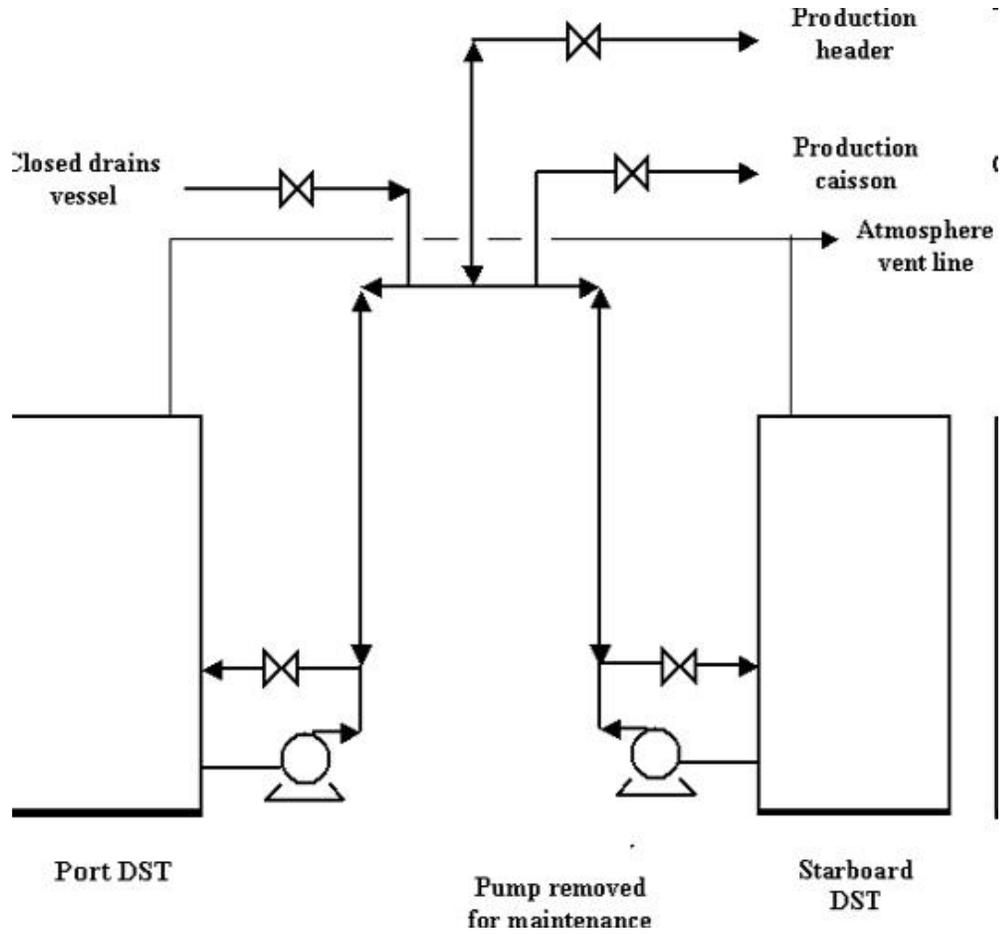
Anexo 4.a
Process Flow Diagram of the Drains storage tanks

The analysis of the most probable causes of the accident has identified the critical event as being the drainage operation of the drains storage tank in the aft port column, which began on the night of March 14, 2001. The oily water in the tank would be pumped out to the platform production header, which receives the flow of oil and gas from the producer wells. From there, together with the production of hydrocarbons, it would flow to the processing plant. However, operational difficulties in starting up the drainage pump of this tank caused reverse flow of oil and gas through the tank discharge lines into the aft starboard tank. The intake valve of this tank was presumably damaged or partially open. The start-up of the pump after 54 minutes decreased the reverse flow of hydrocarbons and the pumped water began entering the aft starboard tank. The continuous pressurization of this tank led to its mechanical failure at about two hours after the start of the drainage operation of the other tank, characterizing the event described as the first explosion, which occurred at 0 hr 22 min of March 15, 2001.

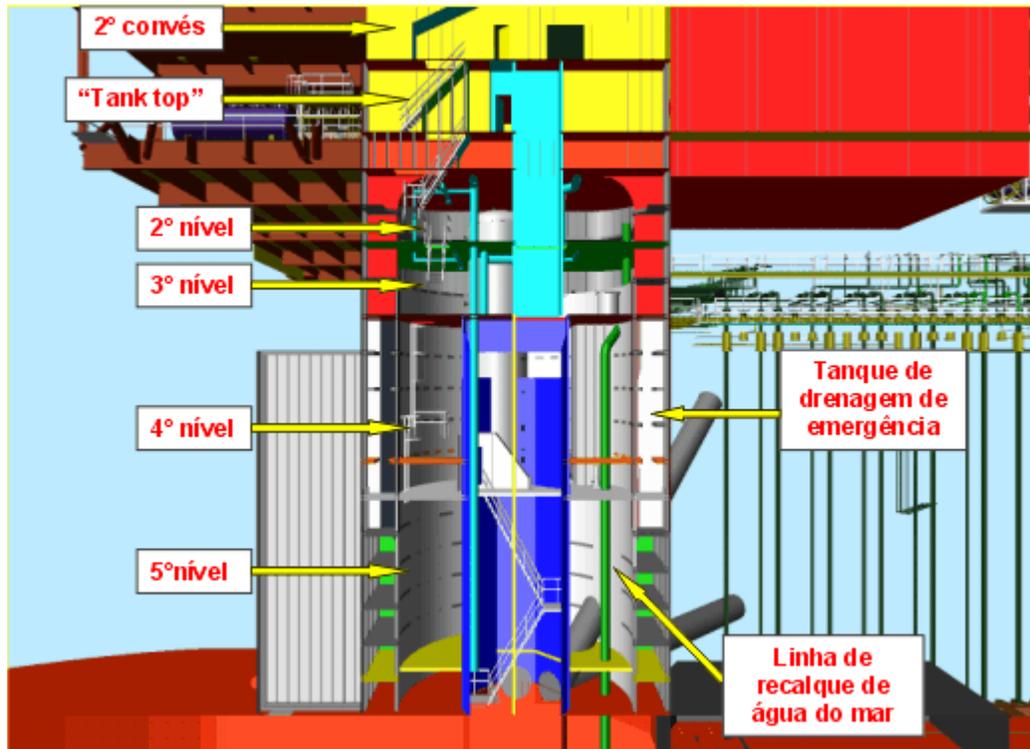
**Annex 6
Aft Starboard Column**

The failure of the aft starboard tank, immediately followed by the rupture of the seawater pumping line passing through the fourth level, made the column to be flooded. As soon as the water reached the dampers of the ventilation system, it started to migrate to the lower part of the column. These dampers allowed the fluids to pass through them because their actuators had not been automatically closed due to mechanical failure.

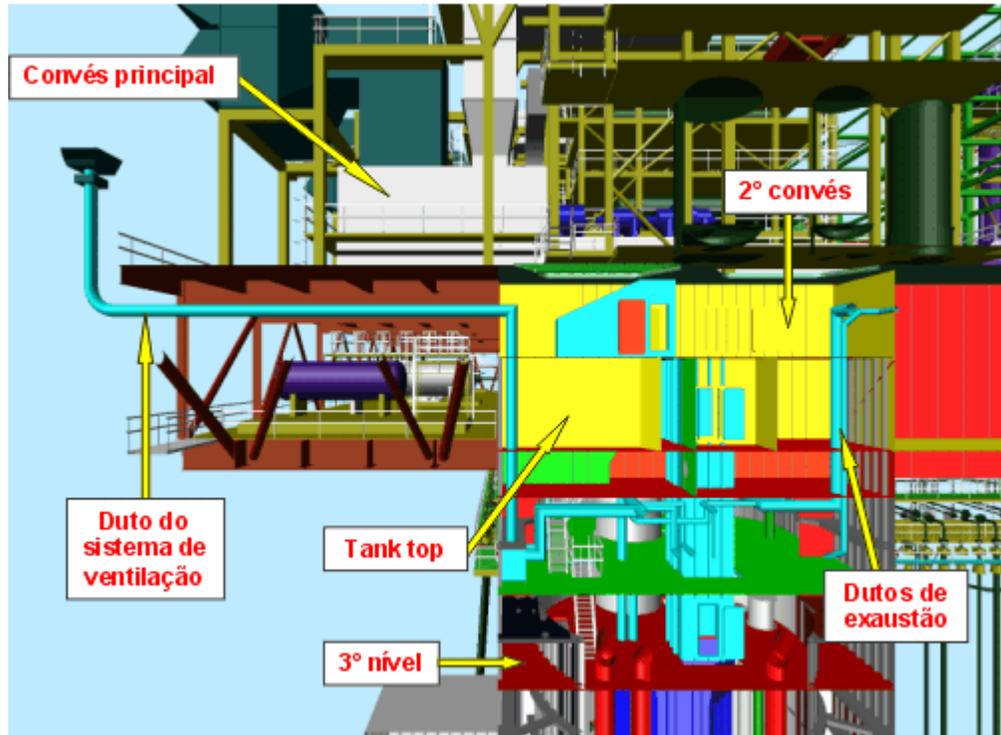
**Annex 7
Decks and upper part of Column**

The fluids from the failed tank and damaged lines began to fill the compartment in the fourth level of the column. There was a gas leak to the other decks through the openings in this compartment and through damaged vent and ventilation lines. Around 20 minutes after the tank failure, a gas explosion took place, striking the area of the tank top deck and the second deck level close to the column. This characterized the event described as the occurrence of the second explosion, killing eleven members of the platform's fire brigade.
