**BRAZILIAN NAVY  
DIRECTORATE OF PORTS AND COASTS**

**INVESTIGATION REPORT OF THE CAPSIZING  
OF THE CONVOY “NORSUL 12 AND NORSUL VITÓRIA”**

**SÃO FRANCISCO DO SUL - SANTA CATARINA**

**- JANUARY 30, 2008 -**

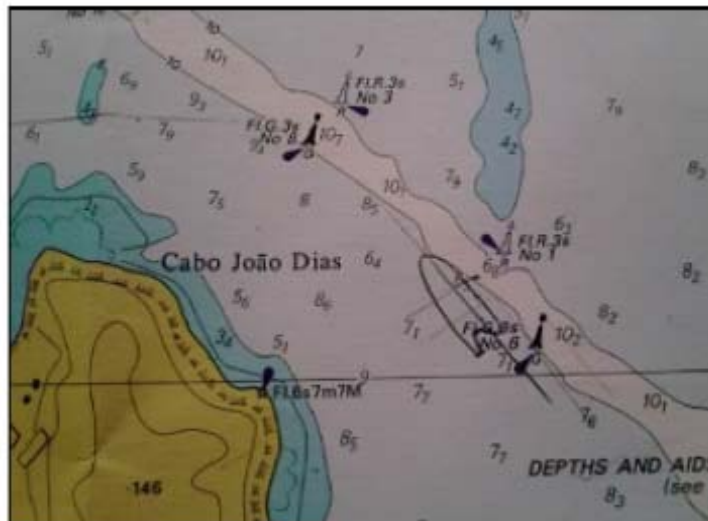
This data was taken from Chart no. 1840 “Access Channel to the Port of São Francisco do Sul”, of the Directorate of Hydrography and Navigation of the Navy (DHN).

Below is a reproduced part of the above mentioned chart with the position of the vessels:
