MSC.1/Circ.1577
16 June 2017

**UNIFIED INTERPRETATION ON THE APPLICATION OF COLREG
WITH RESPECT TO THE PLACEMENT OF SIDELIGHTS**

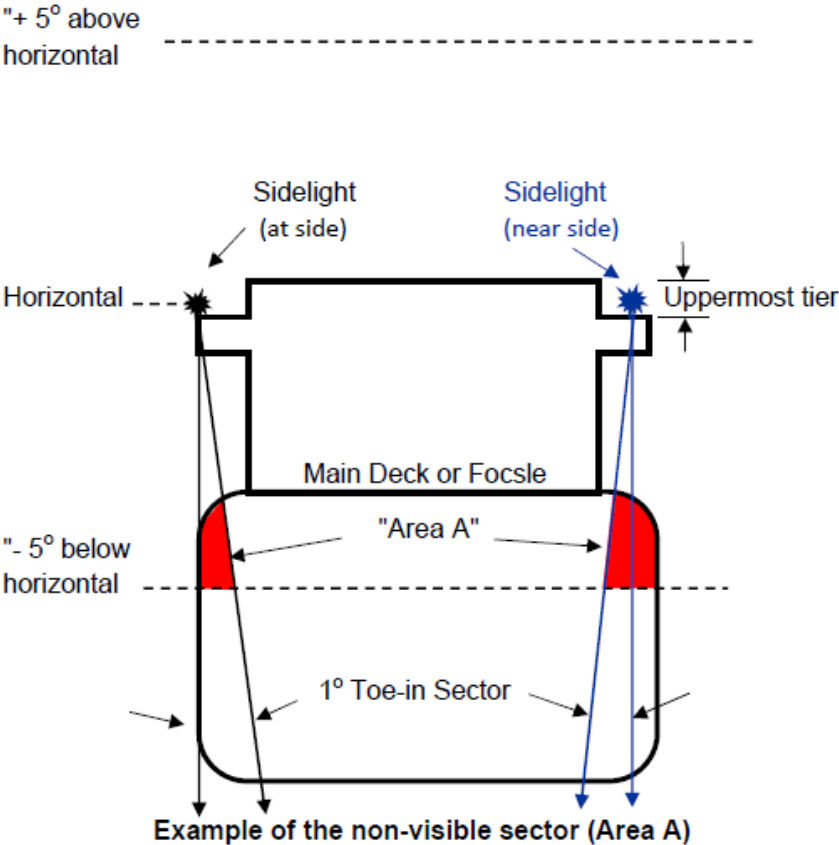
Where sidelights, installed in a position at or "near the side",¹ are not fully visible at all angles from 5 degrees above to 5 degrees below the horizontal including the 1° toe-in sector (e.g. see Area A), then that installation is acceptable provided the installed sidelights are visible, with the ship in all normal conditions of trim corresponding to the lightest seagoing draught in the approved *Trim and stability booklet*, at a minimum distance of 1000 m measured from the stem when viewed from sea level throughout the horizontal plane of 112.5° defined by rule 21(b) including the horizontal 1° toe-in sector in the forward direction prescribed in 9(a)(i).
